Inspection Report

Somewhere NH

1 Report Information

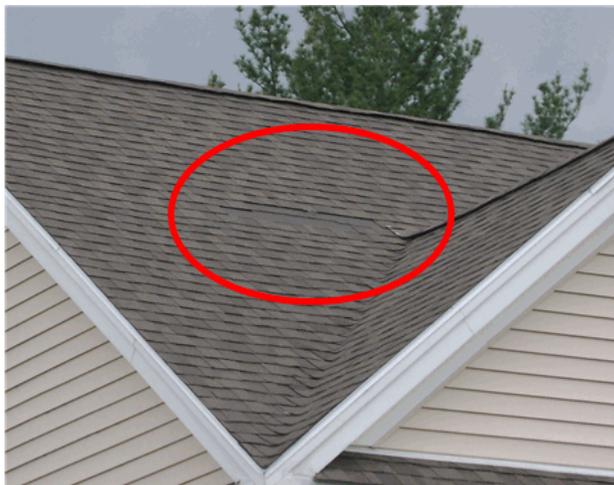
2) Roof Covering Condition

R There appeared to be at least one missing shingle on the front section of roof. Recommend further evaluation and repair as needed by a qualified / licensed contractor. The inspector can not offer an opinion as to whether the roof leaks today unless it is moderately raining at the time of inspection. Client should obtain full disclosure / history information from the seller prior to close.

Missing Shingle on roof

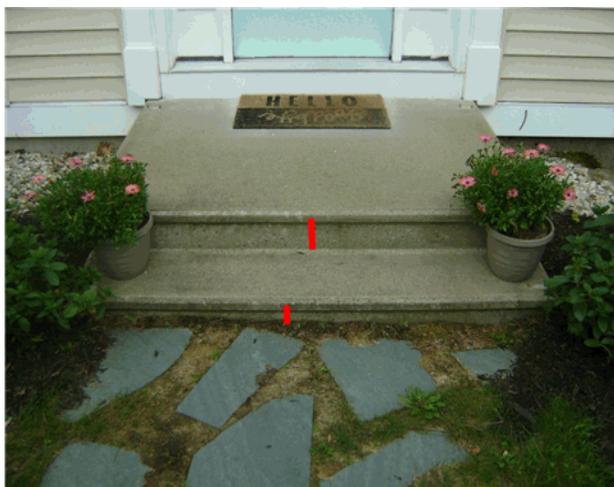
7) Front Entrance Conditions

S The concrete steps into the front entry of the home appeared to have be sinking a bit at the front of the steps. This is causing the concrete pad to be sloped beyond the standard of one quarter inch per foot and is also causing the first step to be substantially smaller than the second step. These conditions may cause trips and falls. It is suggested that a general contractor be contacted for further evaluation and repair.

Different size risers.

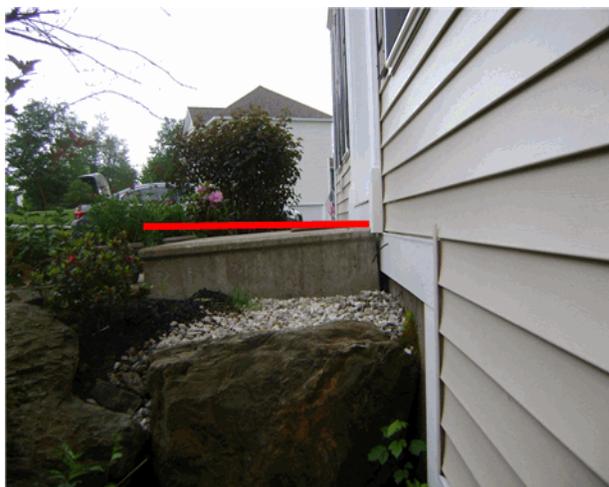
Tilted front steps

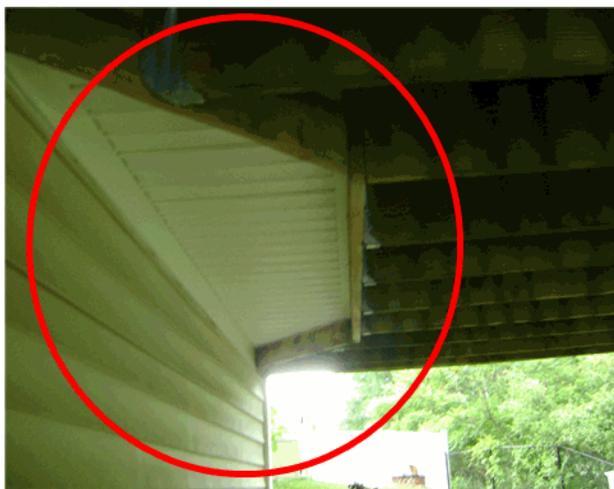
8) Back Entrance Conditions

R At the rear deck there appeared to be multiple repairs needed. The ledger board of the deck was attached to the bump out of the bay window. This is not recommended as the deck adds a substantial load to that connection point via snow and dead weight. Bay window bump outs are cantilevered and are typically built to only hold its own weight. There was also a gap between the boards of the carrying beam. This appeared to be due to the lack of fasteners holding the ply's of the beam together. There should be staggered bolts or approved fasteners along the

It is not recommended to attach a deck to a bumpout

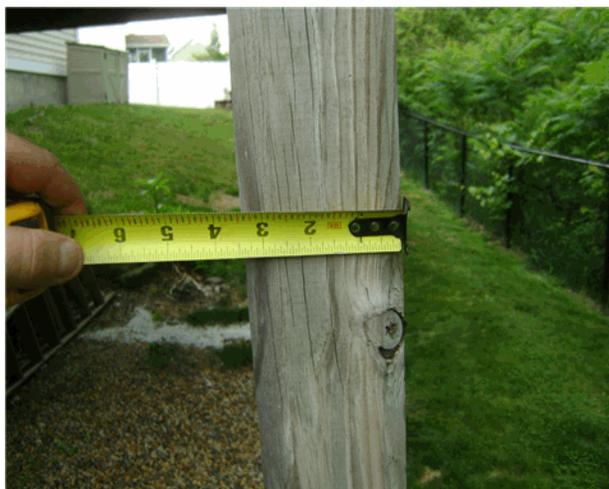
entire length of the carrier. The 4x4 support posts of the deck appeared to be undersized. By today's standards any support post that is taller than 4 feet should be made of a minimum of 4x6 lumber. This is because smaller lumber, like a 4x4, tend to twist as they dry over time. One post appeared to be doing this during the inspection. The bottom step was taller than the maximum standard tread height of 7 3/4 inches. This could cause a trip and fall hazard. The decking appeared to be aging and cracking prematurely for a typical composite material. It appeared to be only a cosmetic defect during the inspection but this area should be monitored in the future and replaced as needed. There also appeared to be a decent sag in the center of the deck. It appeared to be a blemish from the time of installation due to a joist not lining up correctly but it should be evaluated further. It is suggested that a General Contractor and a Structural Engineer be contacted for further evaluation and repair of these items. There also appeared to be no GFCI outlet within 6.5 feet of the deck. Current standards require that a GFCI outlet be on or within 6.5 feet of the deck as to lessen the use of unsafe extension cords stretching across wet conditions or causing trip and fall hazards near and around the deck. It is suggested to contact an electrician for further evaluation and repair.

4x4 is too small for today's standards

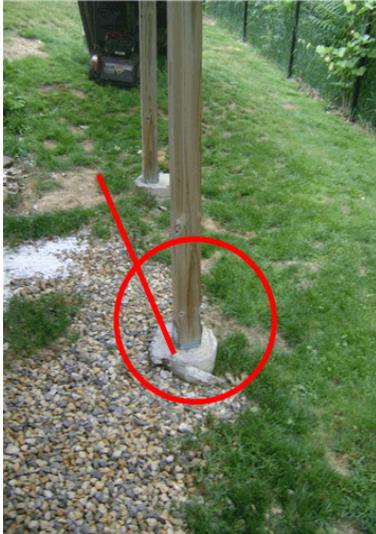
Twisted post due to being undersized

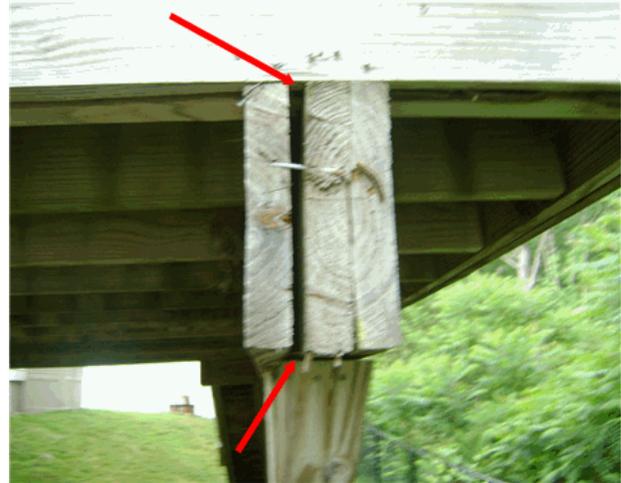
Gap in carrier for deck due to lack of fasteners

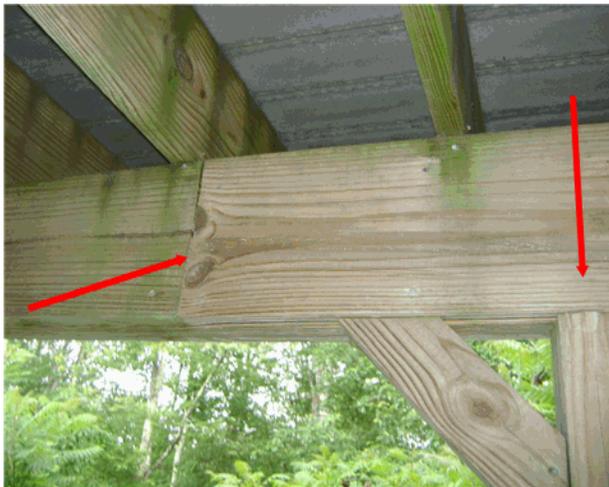
Seams in carriers should fall on a post

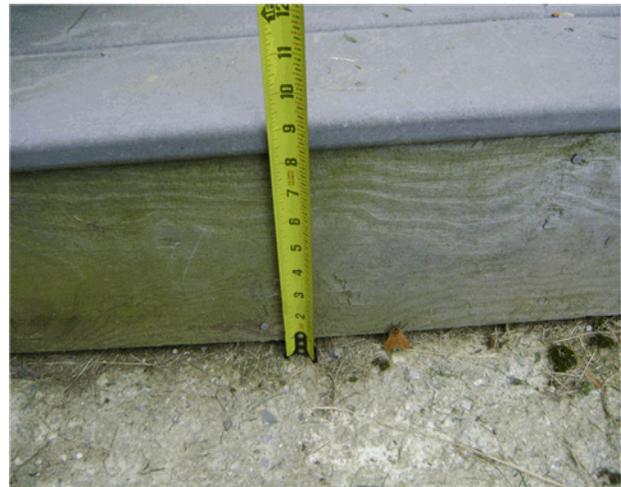
First step on deck stairs is too tall. Maximum of 7 3/4 inches is the standard.

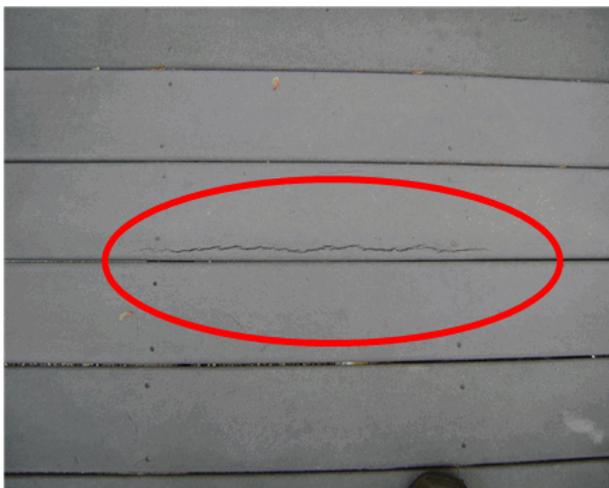
Decking was cracking around screws and in random locations

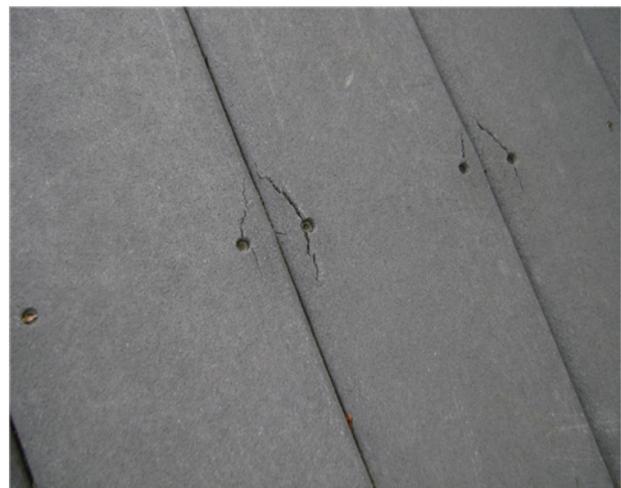
More cracking

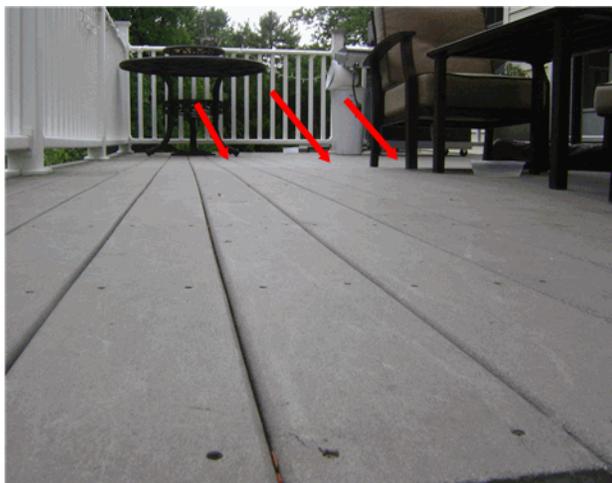
in the center of the deck. It appeared to be a blemish from the time of installation due to a joist not lining up correctly but it should be evaluated further. It is suggested that a General Contractor and a Structural Engineer be contacted for further evaluation and repair of these items. There also appeared to be no GFCI outlet within 6.5 feet of the deck. Current standards require that a GFCI outlet be on or within 6.5 feet of the deck as to lessen the use of unsafe extension cords stretching across wet conditions or causing trip and fall hazards near and around the deck. It is suggested to contact an electrician for further evaluation and repair.
Exterior	9	There were a couple pieces of siding falling out of place at the time of the inspection. This is typical when its the top piece of siding as it sometimes is only clipped into the utility strip above it. It is common practice to put a small nail in the siding to keep this from happening. It should be a fairly simple job to just clip the siding back into place by a general handyman.

Sag in deck

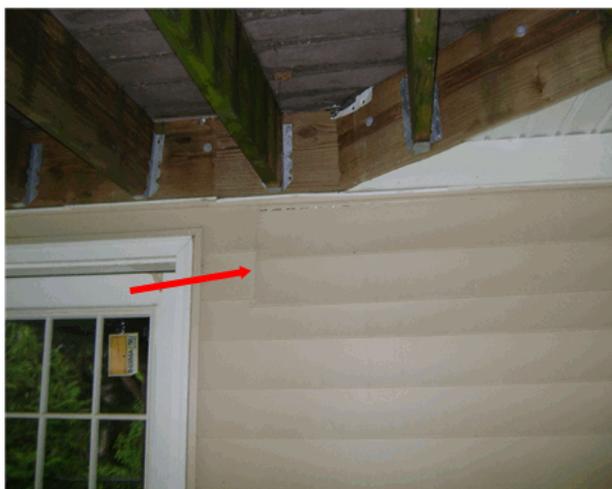
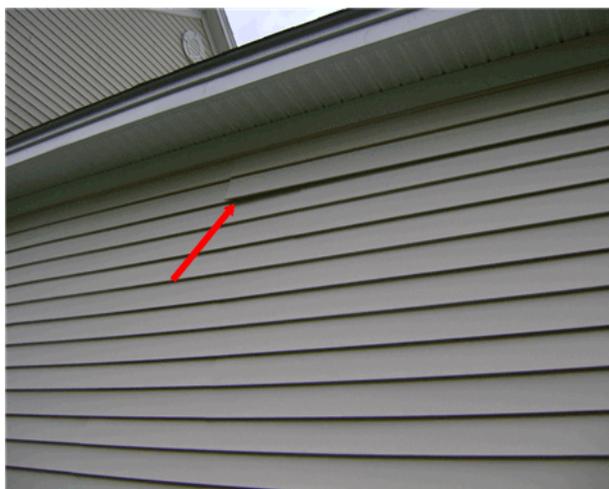
9) Exterior Wall Conditions

R There were a couple pieces of siding falling out of place at the time of the inspection. This is typical when its the top piece of siding as it sometimes is only clipped into the utility strip above it. It is common practice to put a small nail in the siding to keep this from happening. It should be a fairly simple job to just clip the siding back into place by a general handyman.

Falling siding

More falling siding

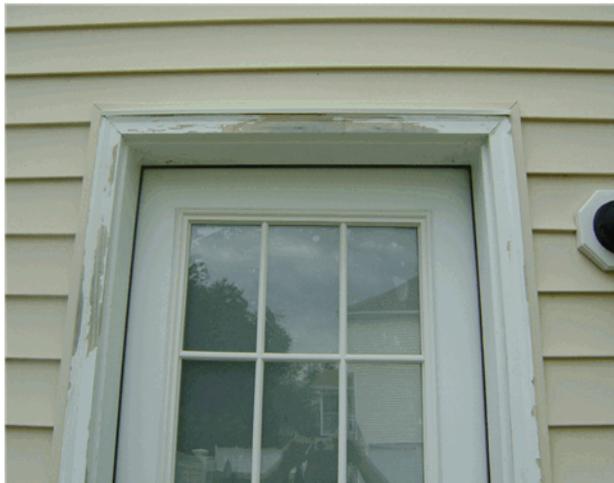
11) Exterior Door Conditions

The exterior entry door to the garage appeared to need a new coat of paint. Paint will help keep the wood trim from rotting as quickly. Recommend contacting a painter or general handyman.

Exterior garage door

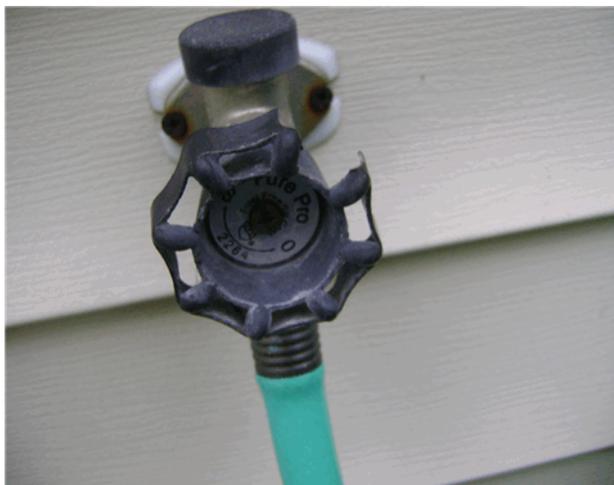
12) Faucet Conditions

The spigot on the rear of the home had a broken handle. It should be an easy repair for a general handyman. The faucet is a frost free type which is good.

Broken handle

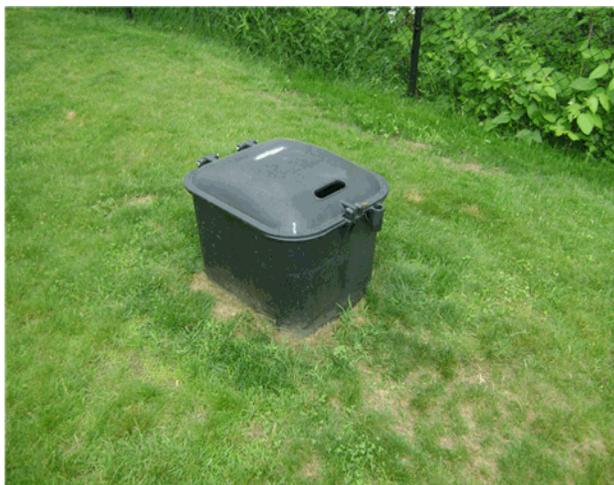
18) New parameter name 1 NI The propane tank was labeled as a 500 gallon tank. The tank is underground in the back yard and I was unable to inspect it. Recommend contacting the propane delivery company for maintenance and the life expectancy of the tank. The main gas shut off is under the lid of the black box in the back yard.

Underground propane tank

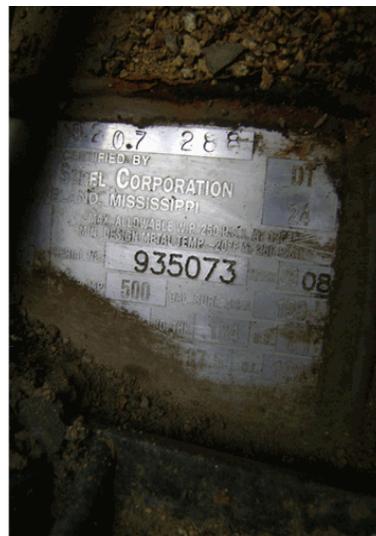
Propane tank info plate

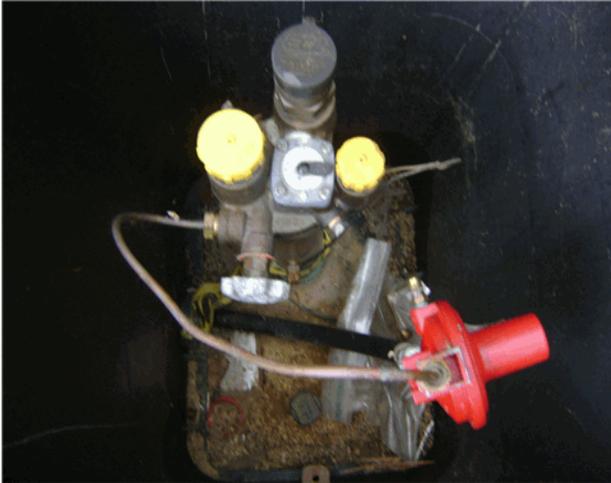
Gas shut off at the propane tank

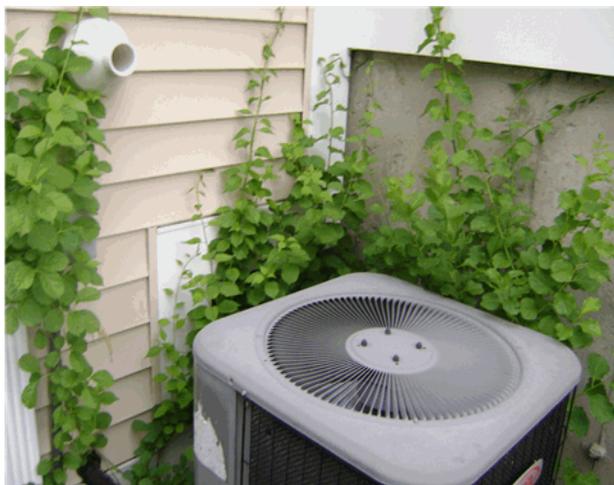
23) AC Unit Conditions

R **There was dense vegetation growing around and into the AC condenser at the rear of the home. This vegetation should be cut back. The condenser needs adequate air flow to function correctly and a lack of air flow may shorten the lifespan of the unit and cause poor performance.**

Dense veggitation around condenser

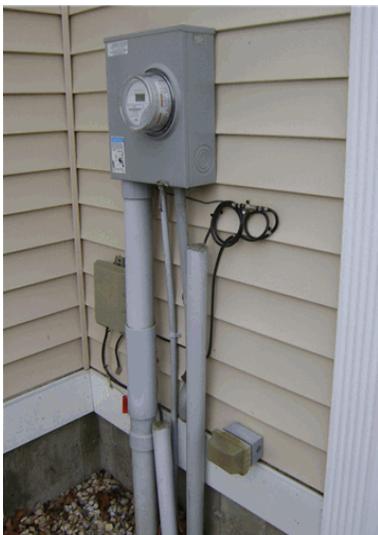
Appears Serviceable The main service entry appeared to be in serviceable condition at the time of inspection.

Electrical service and meter

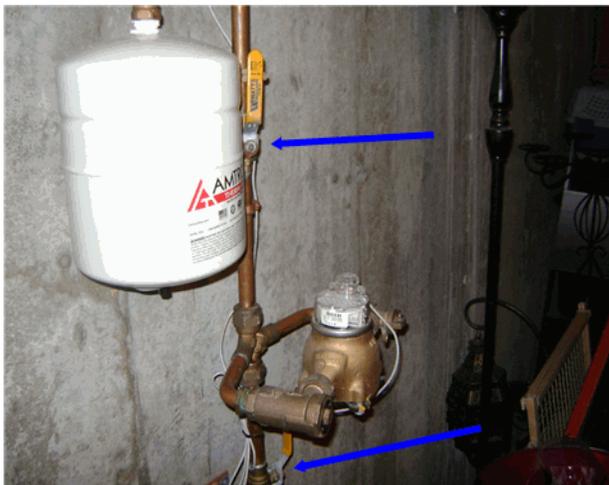
Appears Serviceable The visible portion of the main pipe and valve appeared to be in serviceable condition at the time of the inspection.

Water main shutoff

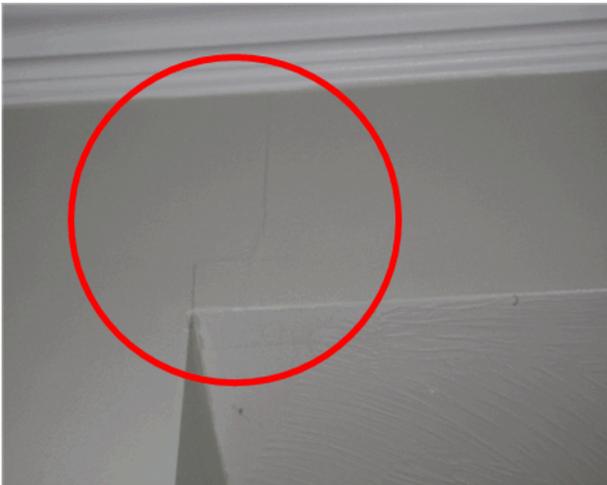
32) Wall Conditions

Appears Serviceable The general condition of the walls appeared to be in serviceable condition at the time of the inspection. There was a typical stress crack found in the master bedroom and only appears to be a cosmetic issue. Recommend repairs as needed.

Typical stress crack in master bedroom

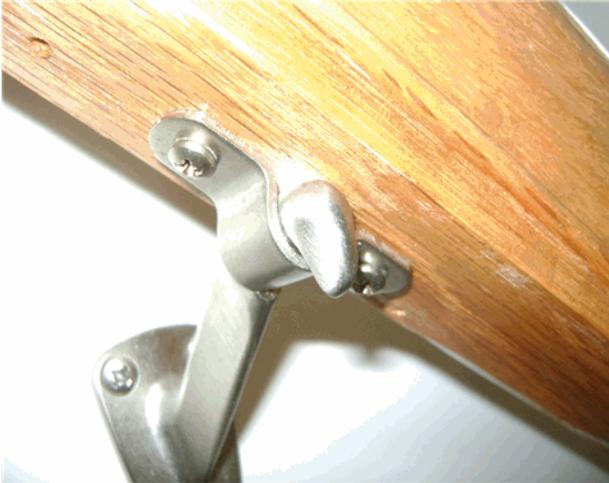
One of section of handrail at the second floor stairway had a loose bracket connection. This should be re-secured so that the handrail does not fall away from the brackets and cause a fall hazard. Recommend contacting a general handyman to repair this.

Loose handrail connection at second floor stairway

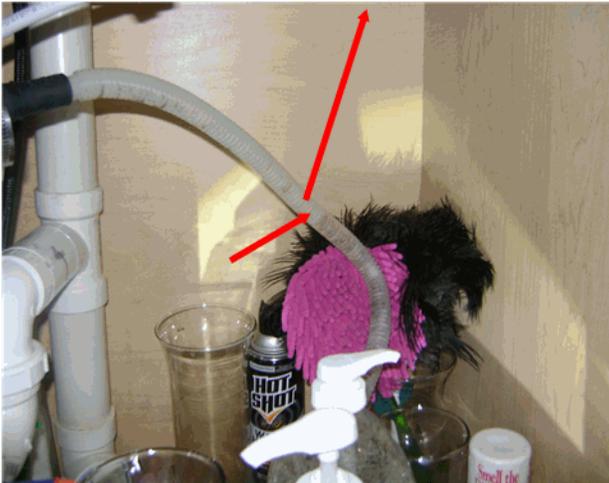
59) Dishwasher Conditions

R **The drain piping for the dishwasher did not have a "high loop" attachment. Today's standards require that the drain line be connected to a point just below the counter top before it continues to the sink drain. This limits any back-flow of contaminated water from the sink to the dishwasher.**

Should be connected making a high loop

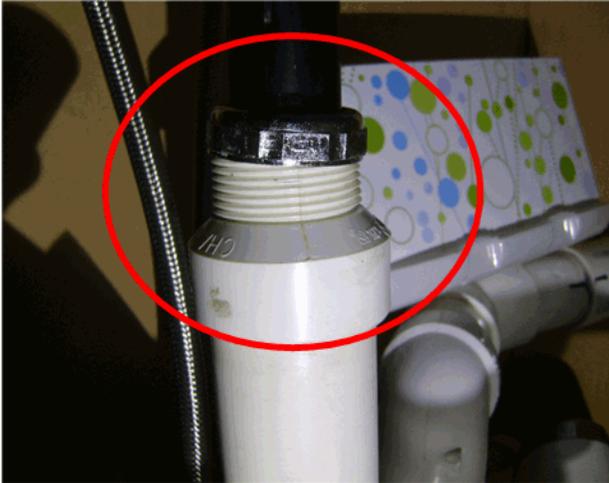
70) Sink Conditions R **One of the drain fittings appeared to be cross threaded at the 1st floor bathroom sink. This fitting did not appear to be leaking at the time of the inspection but it should be repaired so that it does not leak. Recommend repair by a general handyman or plumber.**

Cross threaded fitting at 1st floor
bathroom sink

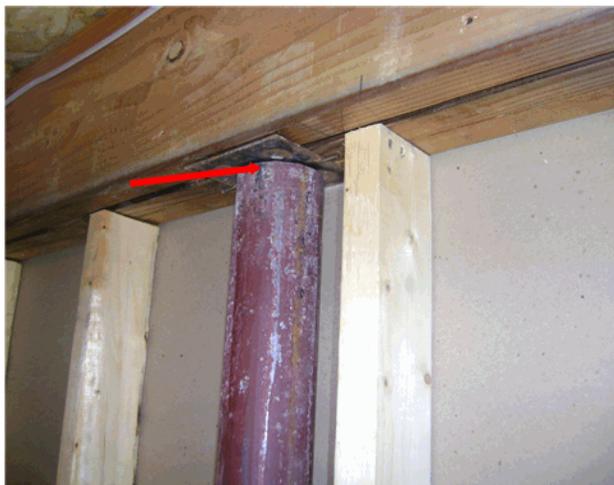
Loose post in basement

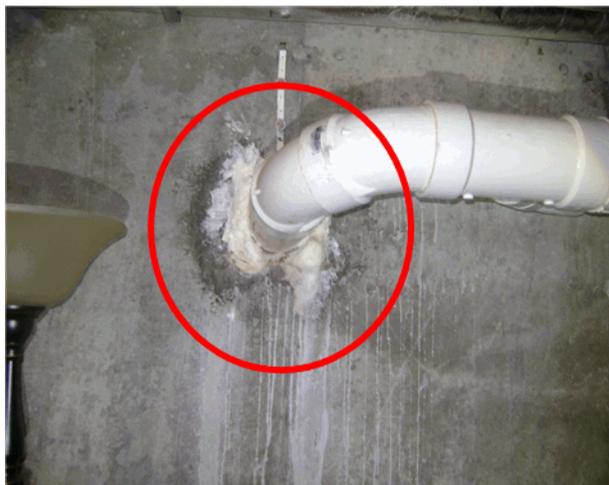
foam does not stop moisture or critters. Recommend contacting a general contractor for repair and evaluation.

spray foam around drain line

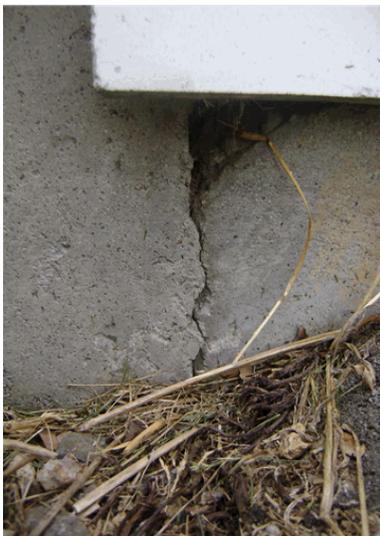
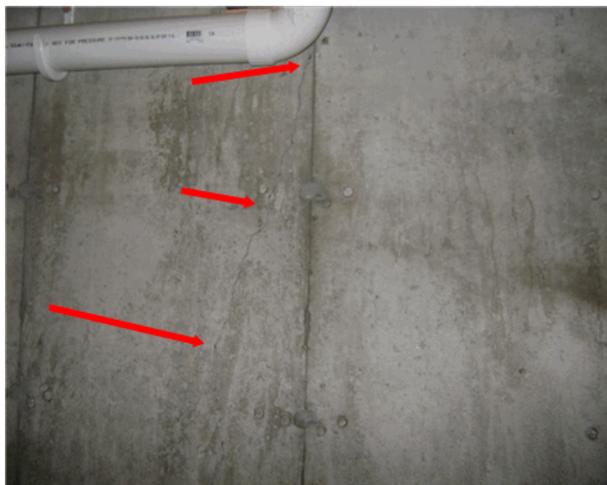
95) Foundation Conditions

R There was one larger crack in the foundation below the garage exterior entry door. This should be repaired so that it does not get larger. There was also a normal looking stress crack in the basement on one of the walls. This crack appeared to be about a quarter of an inch near the top and smaller as it went down. This crack should be filled at minimum and evaluated further by a foundation expert.

Large crack below garage entry door

Crack in foundation
